JUNO

PROBLEM-SOLVER
GUIDE FOR DIFFERENT
PATHOLOGIES

This problem-solver guide includes the most frequent pathologies that have been detected over the years, and aims to help you quickly identify the causes of and the recommended solutions for the most common problems for paints, primers and stains.

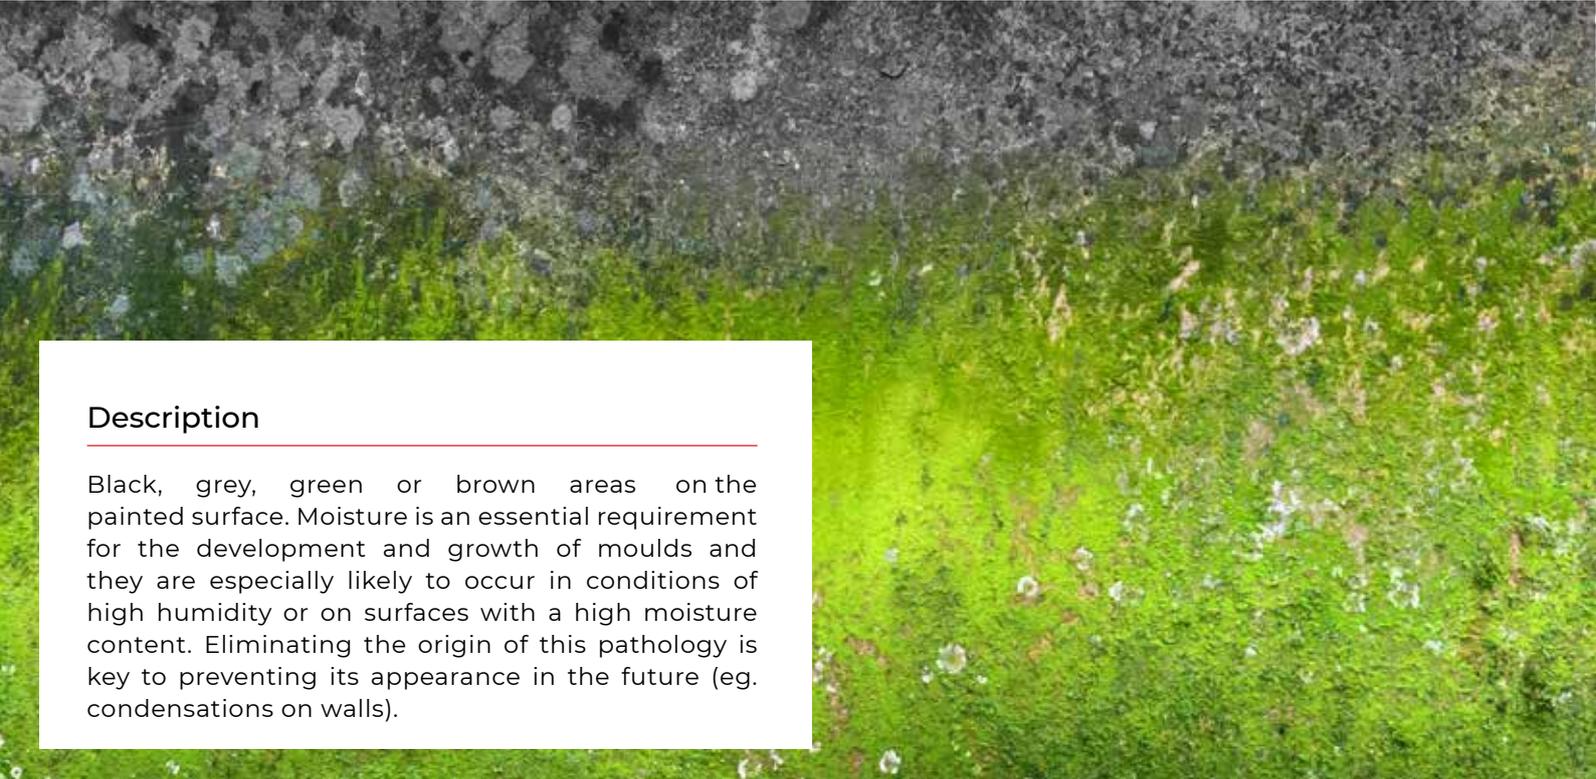
Mould

Black, grey, green or brown areas on the painted surface. Moisture is an essential requirement for the development and growth of moulds and they are especially likely to occur in conditions of high humidity or on surfaces with a high moisture content. Eliminating the origin of this pathology is key to preventing its appearance in the future (eg. condensations on walls).

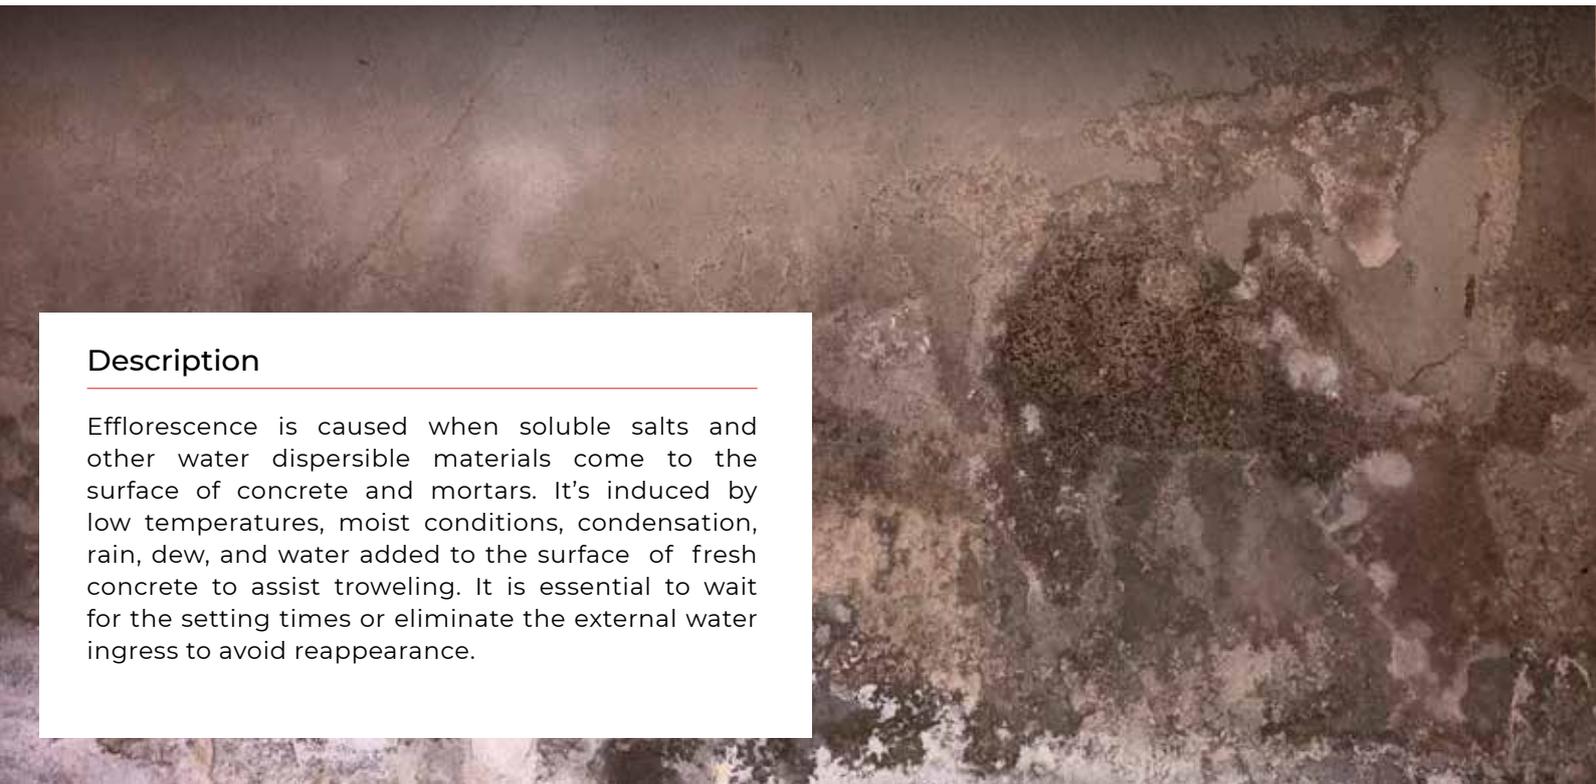
Efflorescence is caused when soluble salts and other water dispersible materials come to the surface of concrete and mortars. It's induced by low temperatures, moist conditions, condensation, rain, dew, and water added to the surface of fresh concrete to assist troweling. It is essential to wait for the setting times or eliminate the external water ingress to avoid reappearance.

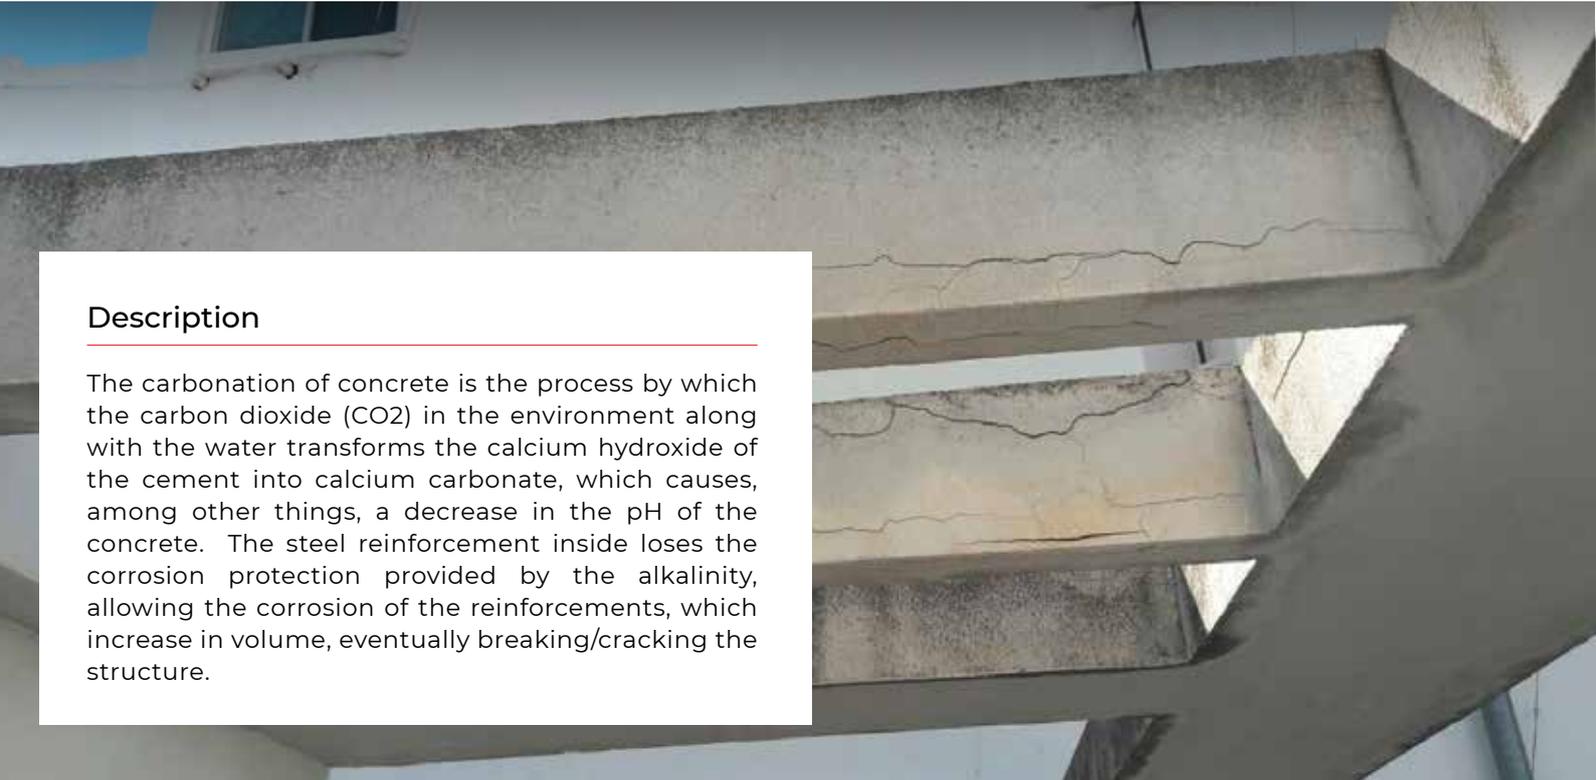
Carbonation

The carbonation of concrete is the process by which the carbon dioxide (CO_2) in the environment along with the water transforms the calcium hydroxide of the cement into calcium carbonate, which causes, among other things, a decrease in the pH of the concrete. The steel reinforcement inside loses the corrosion protection provided by the alkalinity, allowing the corrosion of the reinforcements, which increase in volume, eventually breaking/cracking the structure.

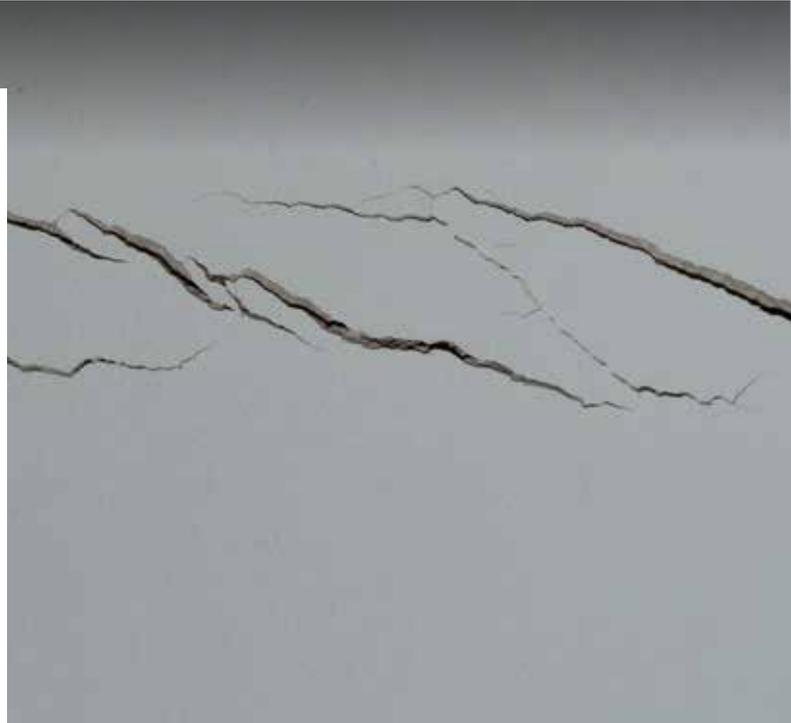
Cracks are indicative of stresses within the coating system which it is not sufficiently flexible to withstand.

This may be the result of ageing and consequent embrittlement of the system; of movement, (e.g. expansion or contraction), in the substrate or of the application of hard-drying coatings over softer ones. There are several types of cracks:

- Cracks in “map form”, generally come from the retraction of the plaster during setting.
- Non-structural cracks / cracks caused by dilation / contraction.
- Structural cracks: Construction defects or execution of the structure. Consult a qualified technician.

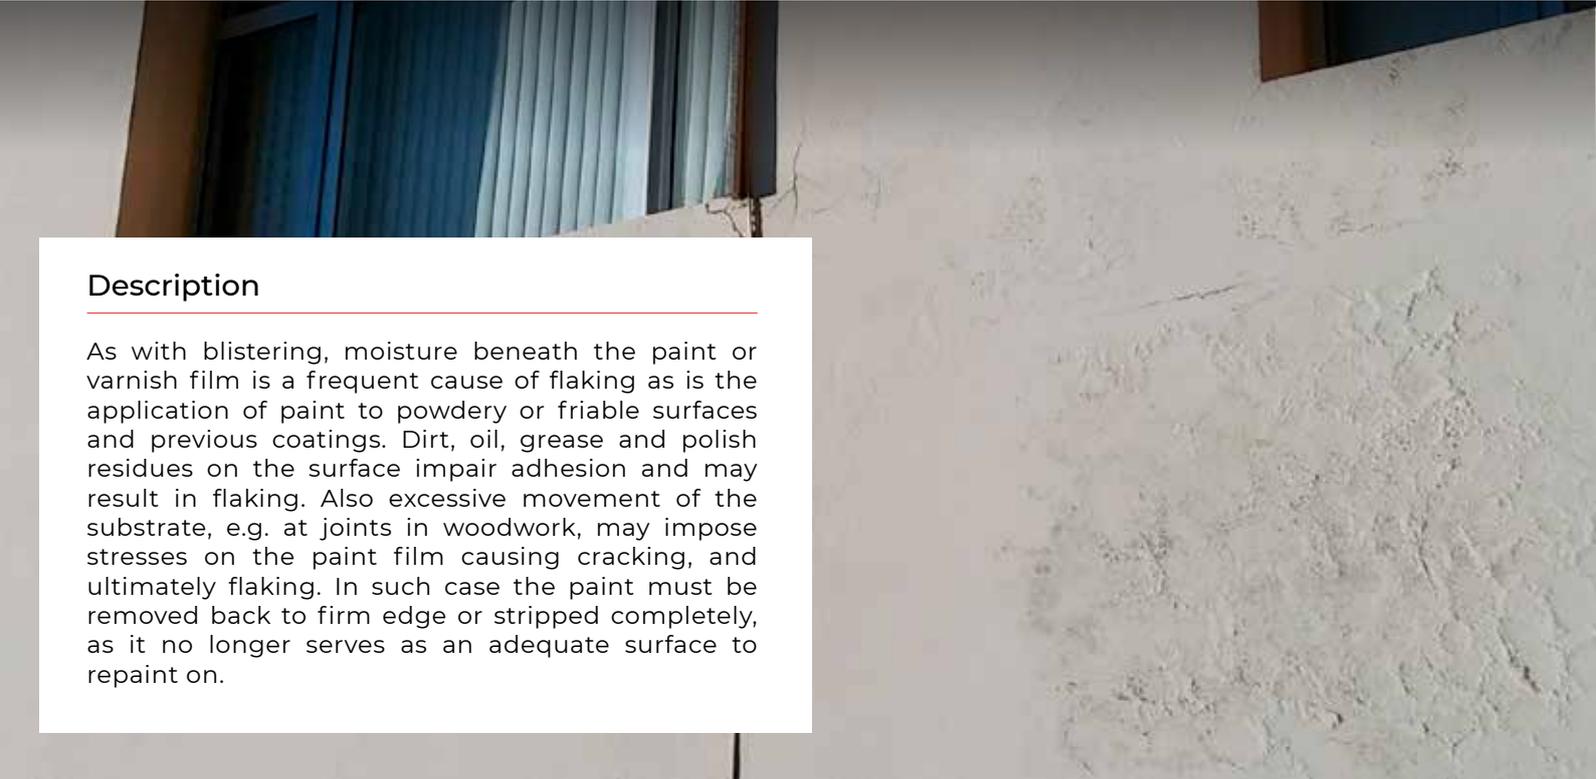
Peeling & Flaking

As with blistering, moisture beneath the paint or varnish film is a frequent cause of flaking as is the application of paint to powdery or friable surfaces and previous coatings. Dirt, oil, grease and polish residues on the surface impair adhesion and may result in flaking. Also excessive movement of the substrate, e.g. at joints in woodwork, may impose stresses on the paint film causing cracking, and ultimately flaking. In such case the paint must be removed back to firm edge or stripped completely, as it no longer serves as an adequate surface to repaint on.

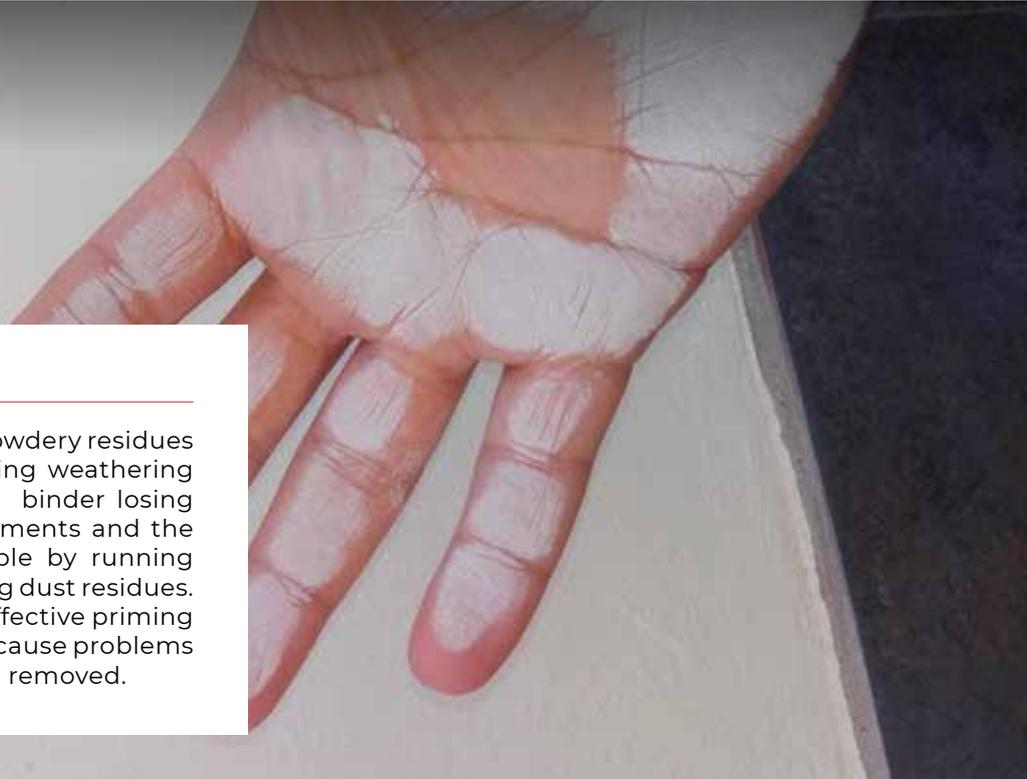
Chalking is the formation of fine powdery residues on the surface of the paint film during weathering and exposure to UV rays due to the binder losing its properties, thus exposing the pigments and the paint's load matter. Easily detectable by running your hand over the paint and observing dust residues. Heavy residues of chalking due to ineffective priming or omitted coats of paint, are likely to cause problems when repainted unless all the paint is removed.

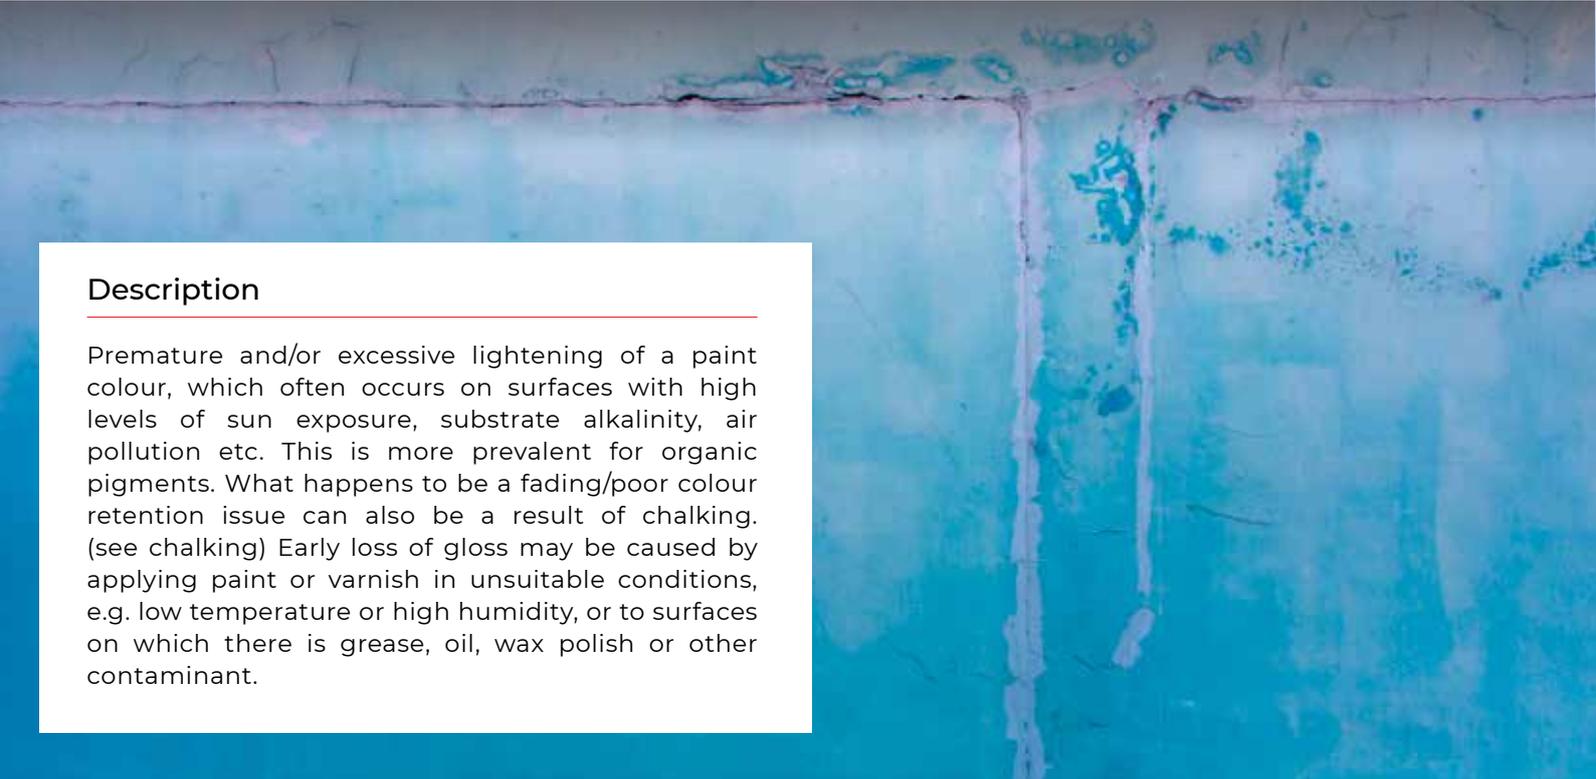
Fading

Premature and/or excessive lightening of a paint colour, which often occurs on surfaces with high levels of sun exposure, substrate alkalinity, air pollution etc. This is more prevalent for organic pigments. What happens to be a fading/poor colour retention issue can also be a result of chalking. (see chalking) Early loss of gloss may be caused by applying paint or varnish in unsuitable conditions, e.g. low temperature or high humidity, or to surfaces on which there is grease, oil, wax polish or other contaminant.

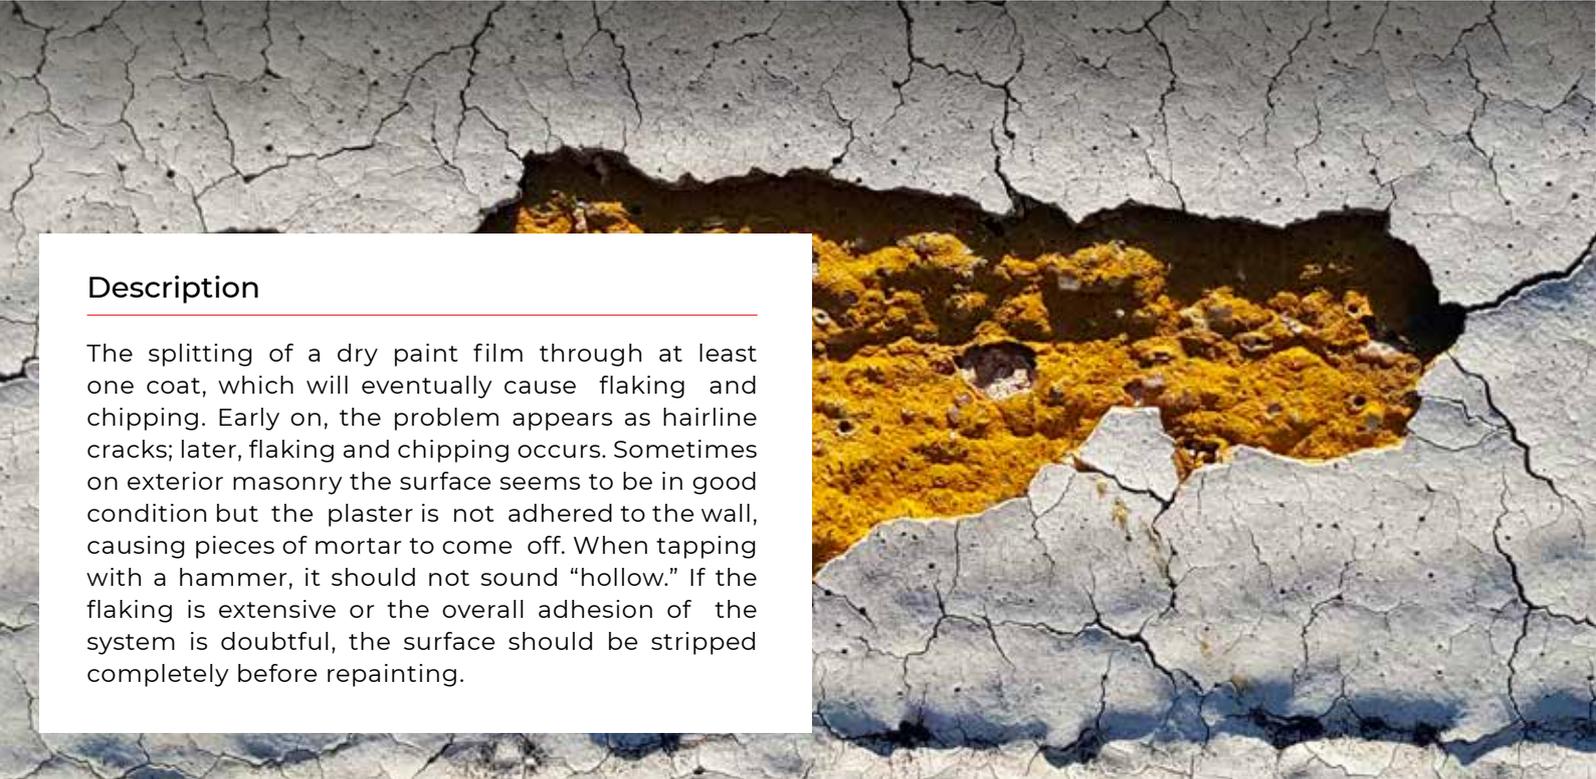
The splitting of a dry paint film through at least one coat, which will eventually cause flaking and chipping. Early on, the problem appears as hairline cracks; later, flaking and chipping occurs. Sometimes on exterior masonry the surface seems to be in good condition but the plaster is not adhered to the wall, causing pieces of mortar to come off. When tapping with a hammer, it should not sound “hollow.” If the flaking is extensive or the overall adhesion of the system is doubtful, the surface should be stripped completely before repainting.

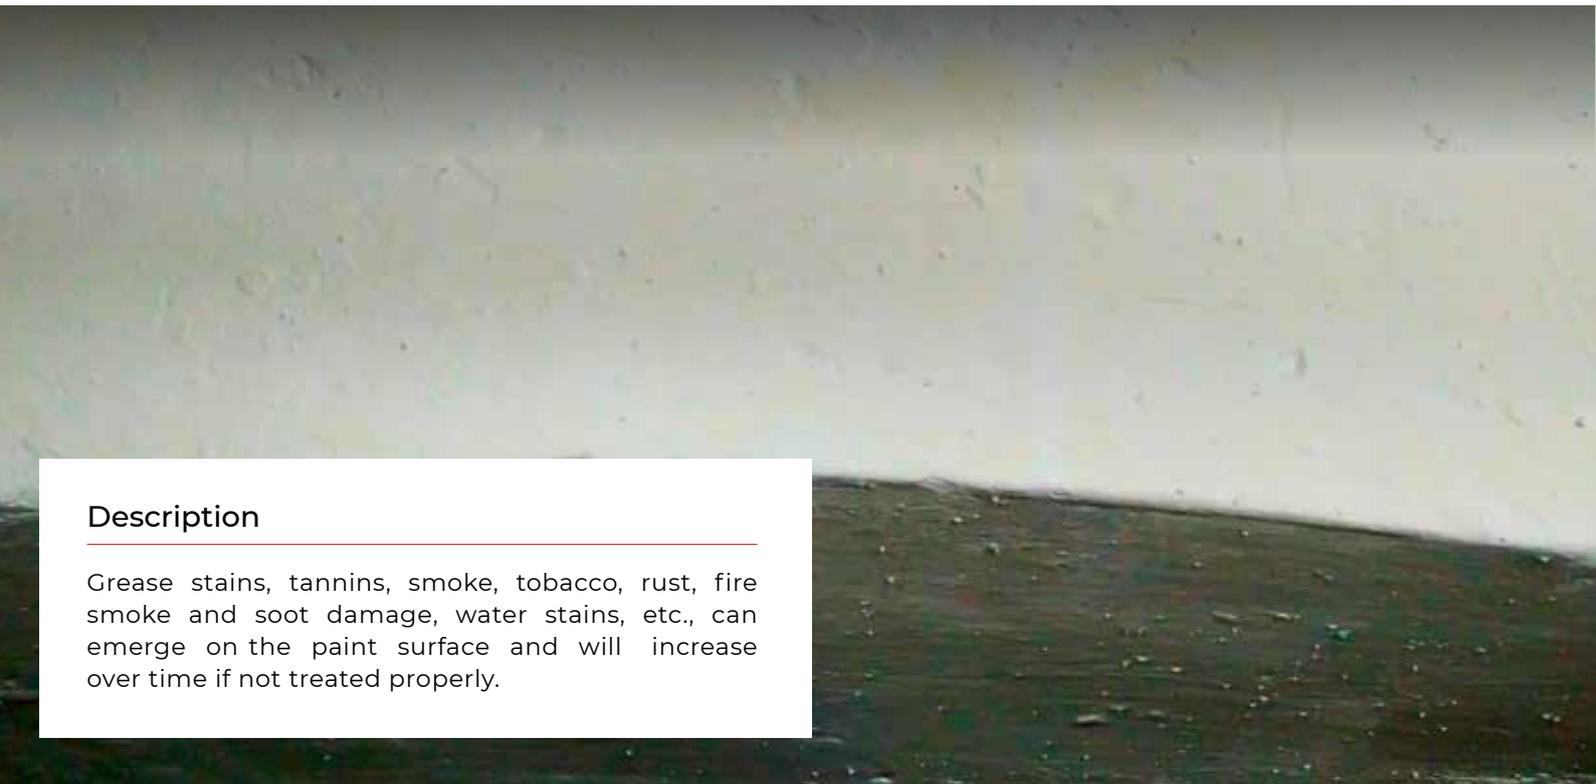
Staining (Interior)

Grease stains, tannins, smoke, tobacco, rust, fire smoke and soot damage, water stains, etc., can emerge on the paint surface and will increase over time if not treated properly.

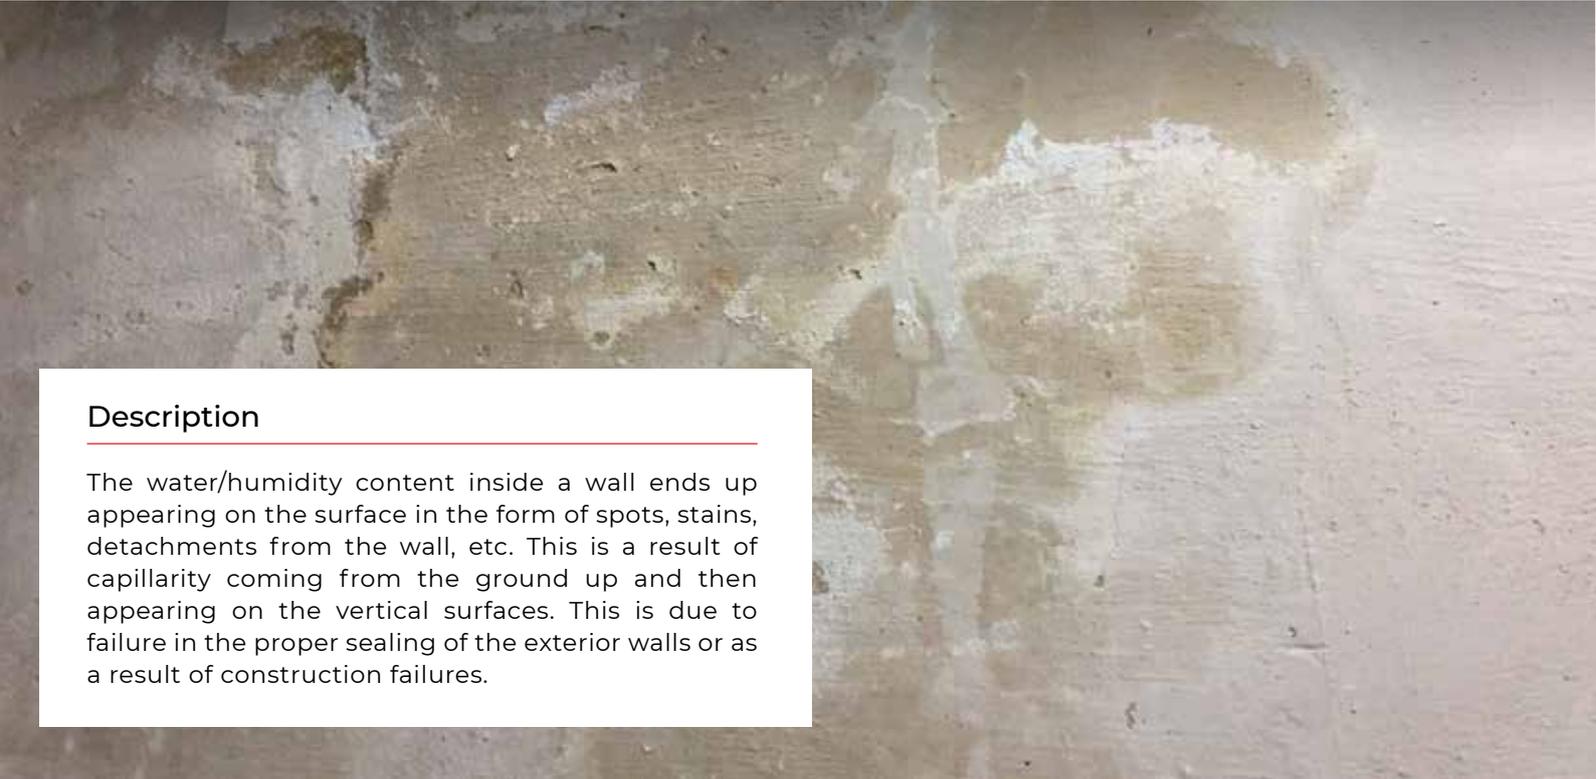
Humidity

The water/humidity content inside a wall ends up appearing on the surface in the form of spots, stains, detachments from the wall, etc. This is a result of capillarity coming from the ground up and then appearing on the vertical surfaces. This is due to failure in the proper sealing of the exterior walls or as a result of construction failures.

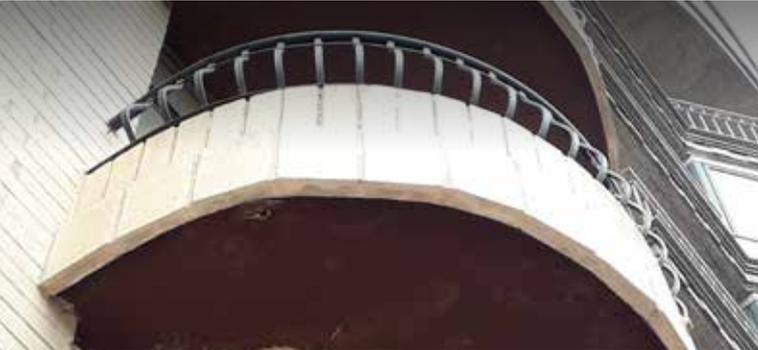
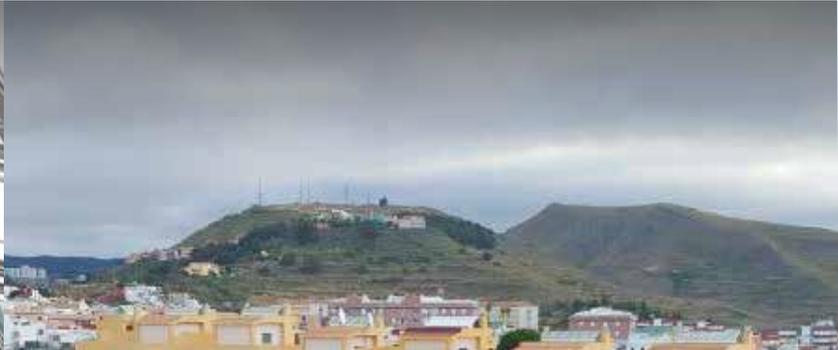
Humidity on horizontal surfaces

On horizontal surfaces such as flat roofs or balconies, filtration of dampness and impermeability defects frequently occur, leading to stains, cracks and efflorescence appearing on lower levels and underneath these surfaces. It is important to prevent water from entering the concrete reinforcement structures so as to avoid premature degradation.

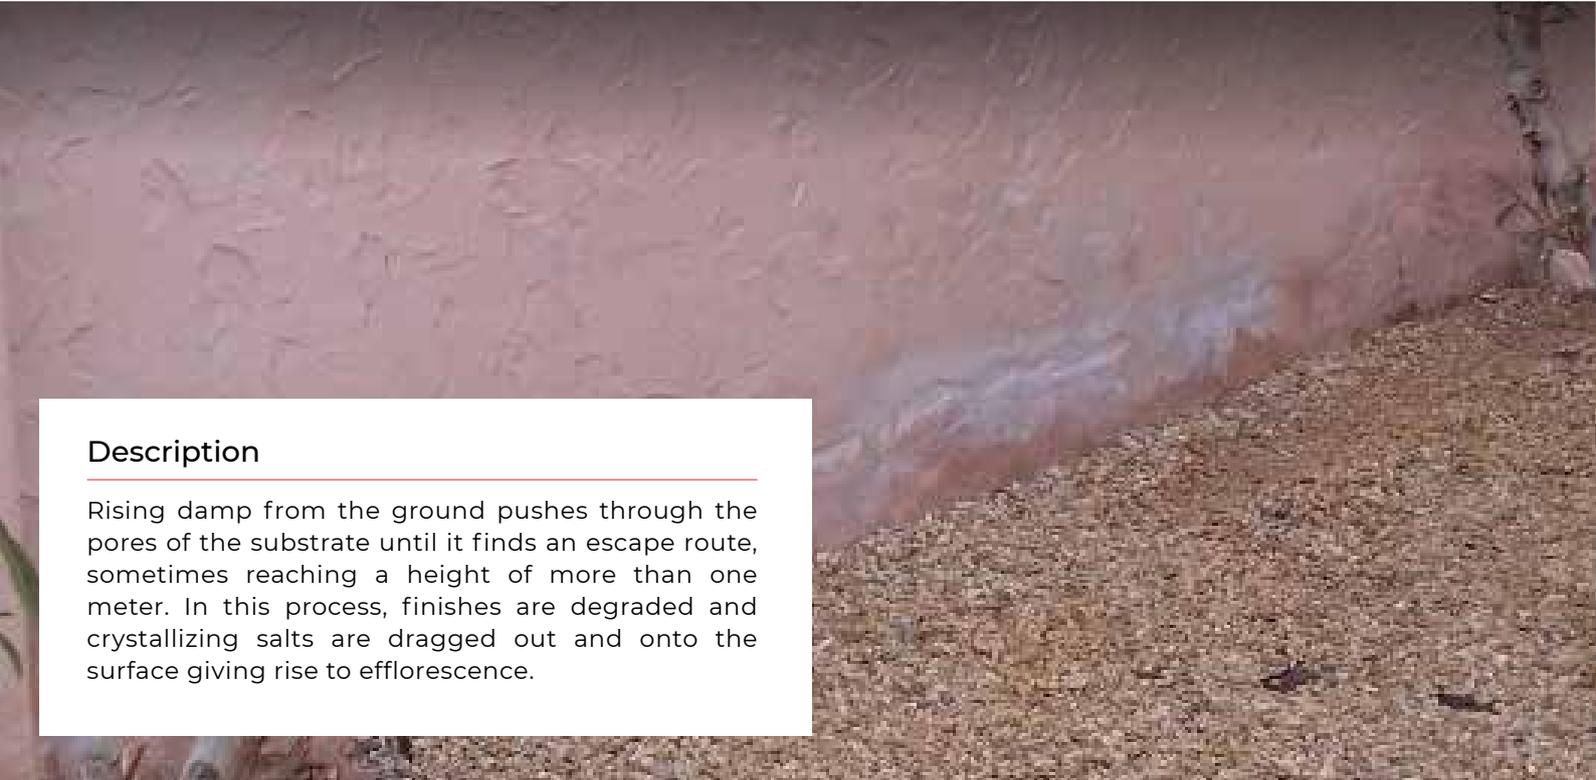
Rising damp from the ground pushes through the pores of the substrate until it finds an escape route, sometimes reaching a height of more than one meter. In this process, finishes are degraded and crystallizing salts are dragged out and onto the surface giving rise to efflorescence.

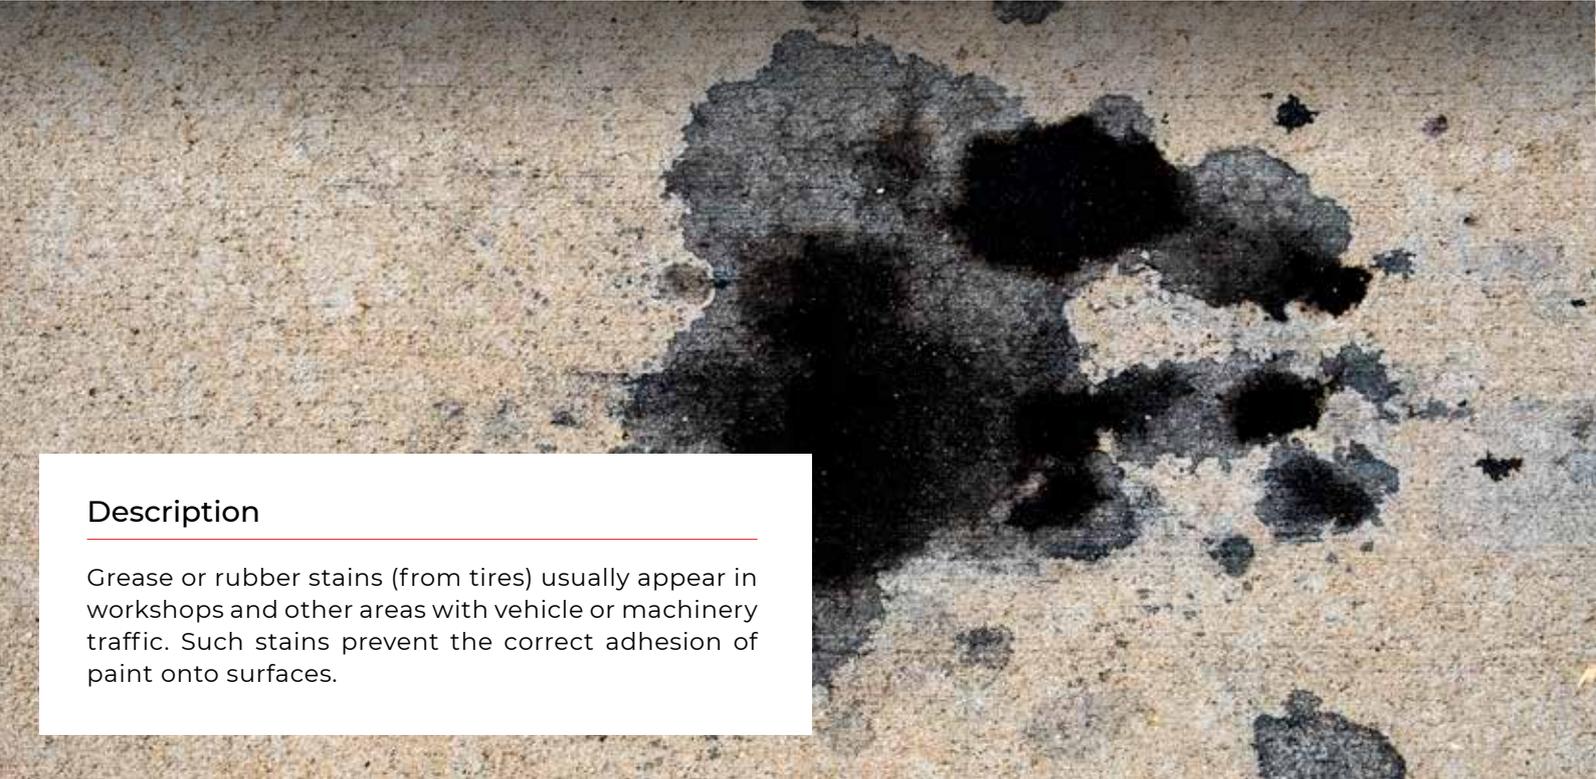
Grease & Rubber

Grease or rubber stains (from tires) usually appear in workshops and other areas with vehicle or machinery traffic. Such stains prevent the correct adhesion of paint onto surfaces.

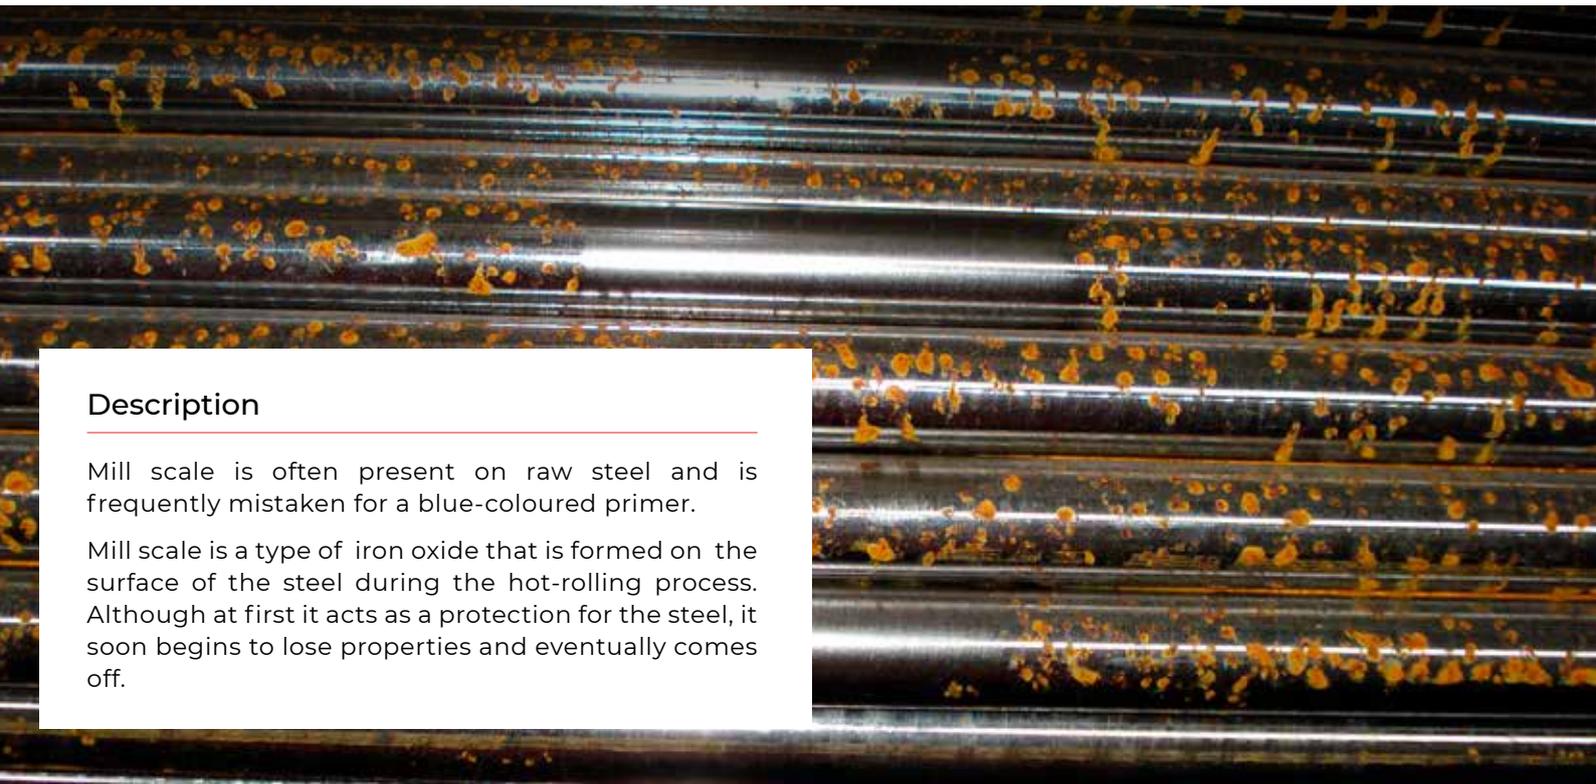
Mill scale is often present on raw steel and is frequently mistaken for a blue-coloured primer.

Mill scale is a type of iron oxide that is formed on the surface of the steel during the hot-rolling process. Although at first it acts as a protection for the steel, it soon begins to lose properties and eventually comes off.
